# Network resilience: update on opening the Gorge

**Road Controlling  
Authorities Forum  
27<sup>th</sup> April 2012**

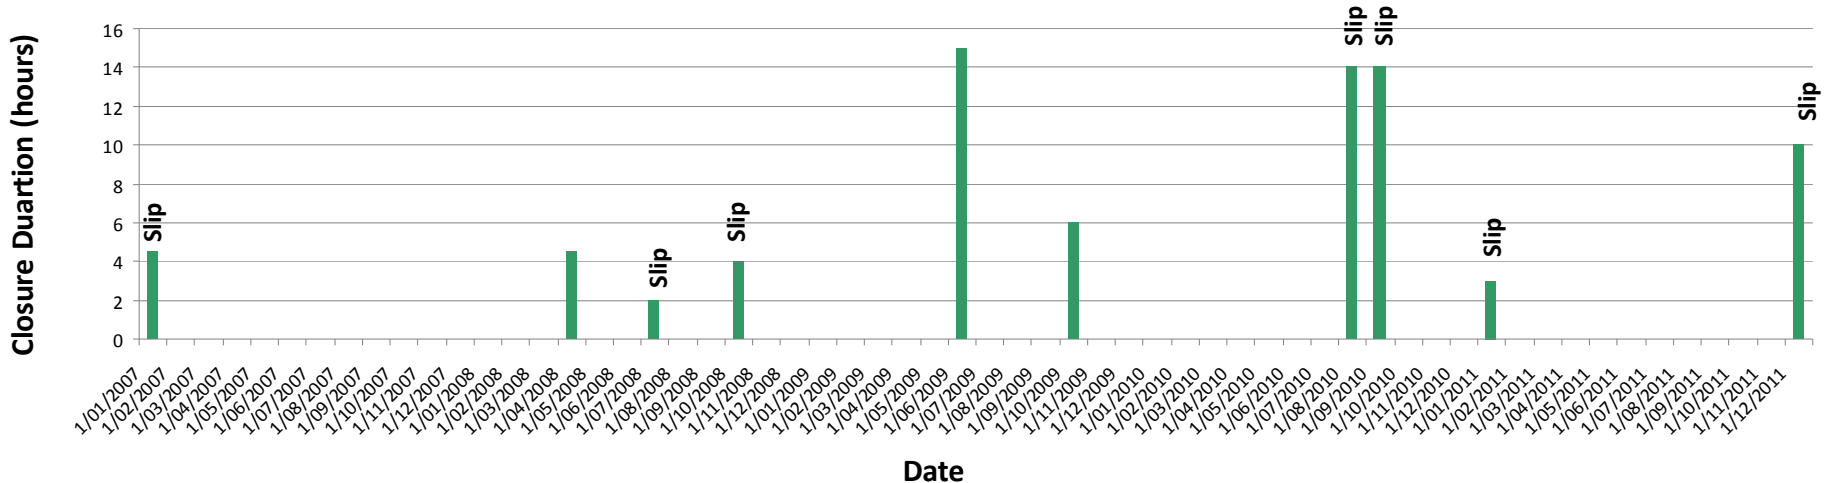
## Waioeka Gorge Closures (2007-2012)

**Of these 11 gorge closures over the last 5 years, slips have been a direct cause of closure 7 times. The other four closures were caused by snowfalls or vehicular roll-overs**

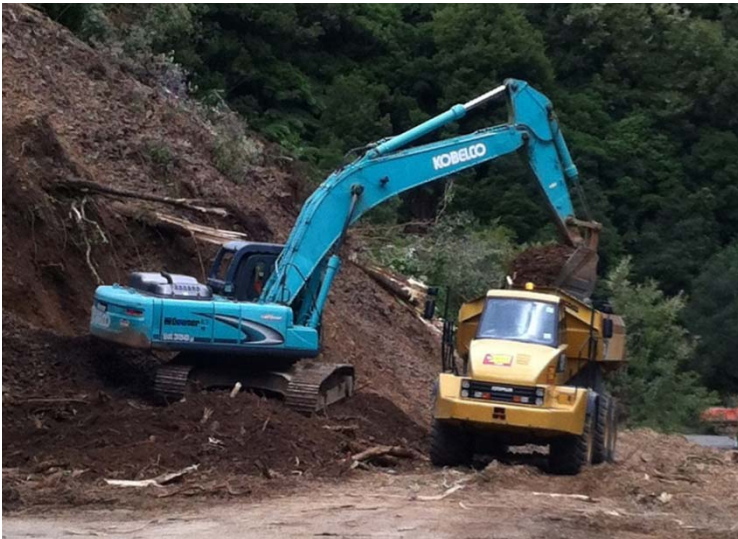
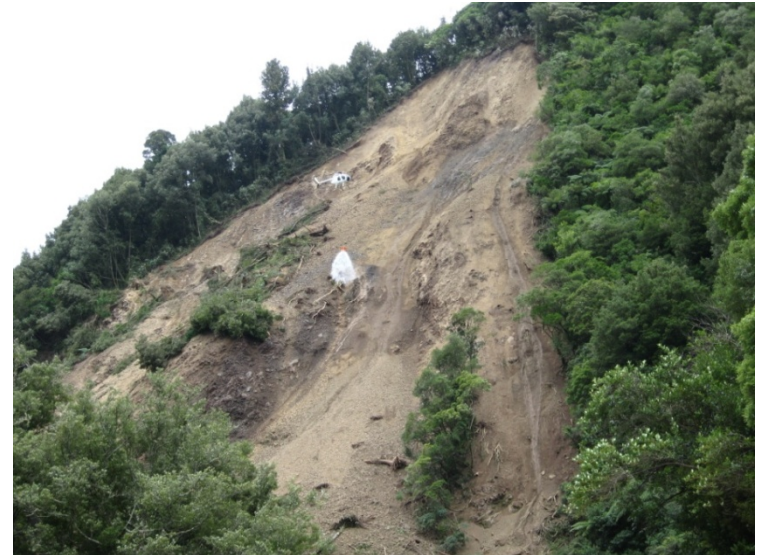
- Continue work with excavation machines to remove the 30,000 cubic metres of slip material from the middle of the slip face (expected to take up to four weeks weather dependant)
- Move to clear the state highway of slip material
- Repair damage to the state highway
- Reopen fully to two lanes
