Coal Tar in Auckland Roads

RCA Forum November 2015

Coal Tar in Auckland

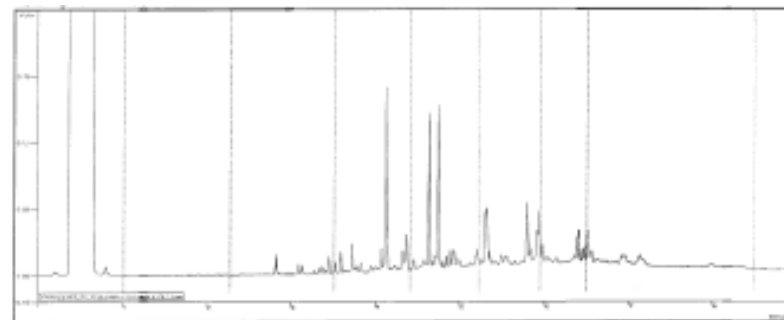
- Elevated PAH concentrations – high 100s or 1000s mg/kg (1888 and 3516mg/kg)
- A GC with peaks similar to the coal tar reference
- Ratios are a bit random – 0.53 and 0.36-0.47
- A radar plot that looks a bit like this.
- Phenols have not been confirmed for historic samples

AT has identified small areas of coal tar in only 11 central city road rehab projects.

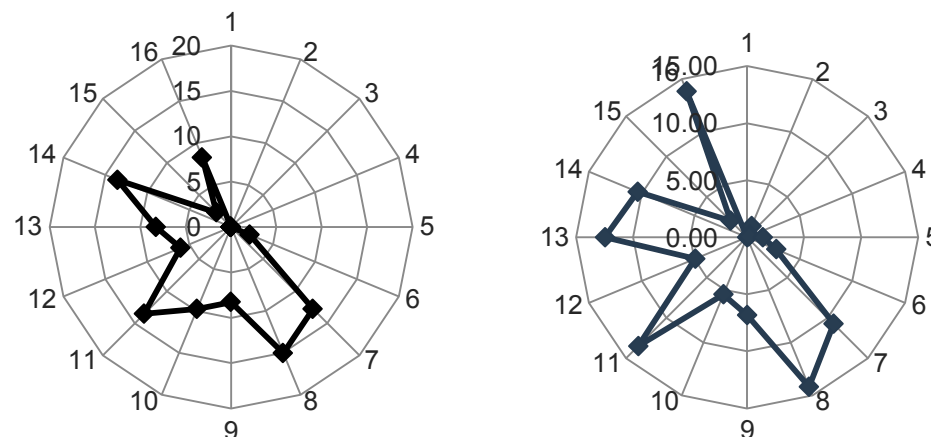
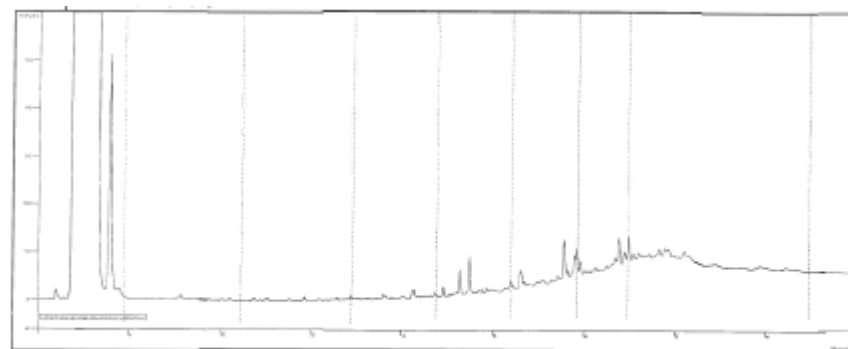
- PAH concentrations typically <100 mg/kg (1.3-29 mg/kg)
- A GC with peaks similar to the bitumen reference or with a heavy oil profile
- Ratios are a bit random – 0.42 and 0.62
- A radar plot like these.
- Absence of phenols can not be confirmed for historic samples.

AT has tested pavements and soil from roads around the region and often found a profile like bitumen.
